NASA Technical Paper 1063

Effects of Continuous
and Cyclic Thermal Exposures
on Boron- and Borsic-Reinforced
6061 Aluminum Composites

George C. Olsen and Stephen S. Tompkins

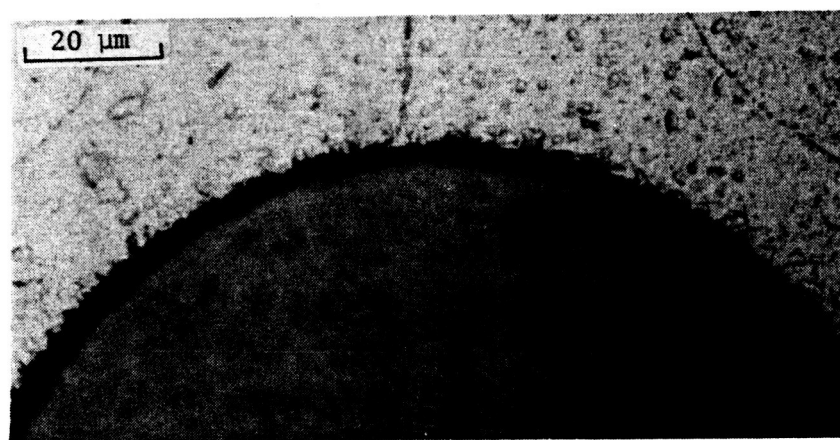
Figure 13.- Cross sections of B/A1 continuously exposed at 783 K.

Fiber/matrix interface and fiber strength.- Cross sections from the specimens were polished and etched with Keller's reagent, which deeply etched the reaction layer. When these specimens are viewed with an optical microscope focused on the plane of the reaction-layer/matrix interface, the morphology of this interface becomes visible. Because of the surface relief caused by the polishing process, the entire reaction layer cannot be brought into focus simultaneously, and as a result, the apparent thickness of the reaction layer may be misleading. Photomicrographs of the reaction-layer/matrix interface of unexposed B/Al specimens and specimens continuously exposed at 728 K and 783 K are shown in figures 12 and 13, respectively. These figures show what appears to be development of acicular growth at the fiber/matrix interface, similar to that reported in reference 10. The unexposed specimens (figs. 12(a) and 13(a)) show little or no acicular growth developed during the fabrication process. Exposure to the elevated temperatures caused the acicular growth to develop

(figs. 12(b) and 13(b)). The growth was more dense for longer exposure time (figs. 12(c) and 13(c)).

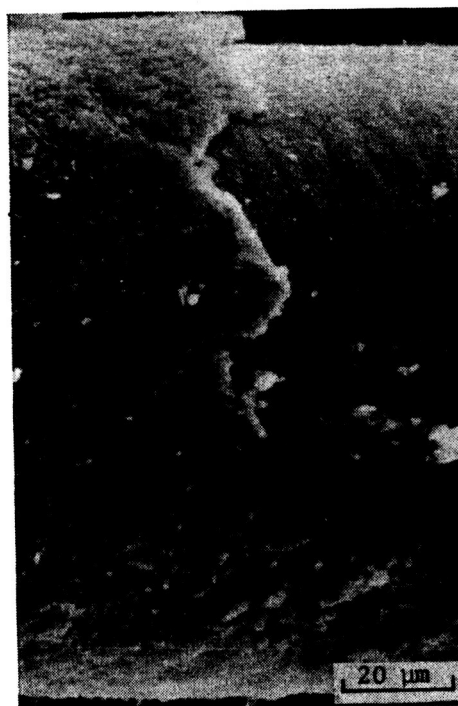
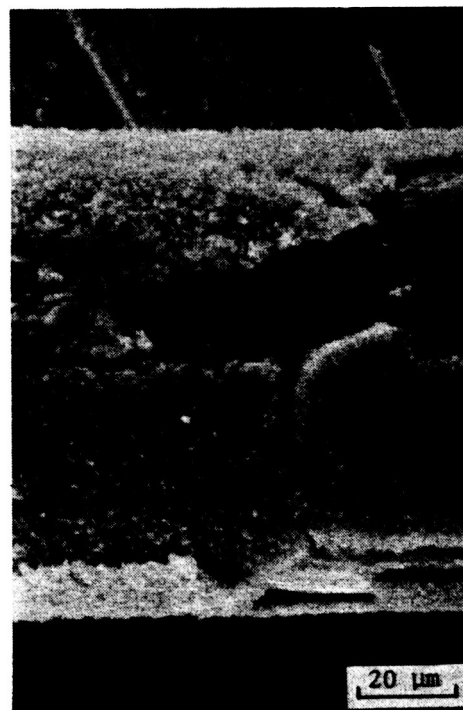
Figure 14.- Surface of fibers from continuously exposed B/Al.

The reaction layer is more distinctly seen on fibers which have been chemically removed from the matrix and then partially etched with Murakami's reagent. These fibers, from an unexposed specimen and from specimens continuously exposed at 728 K and 783 K, are shown in figure 14. The light, discontinuous initial layer on the unexposed specimen is apparent in figure 14(a). Thicker, continuous layers formed during the continuous exposures are shown in figures 14(c), (d), and (e). A fiber from a specimen exposed 170 hours at 783 K to accentuate the reaction layer is shown in figure 14(f). The fluffy texture of the reaction layer may be attributed to the acicular growth.

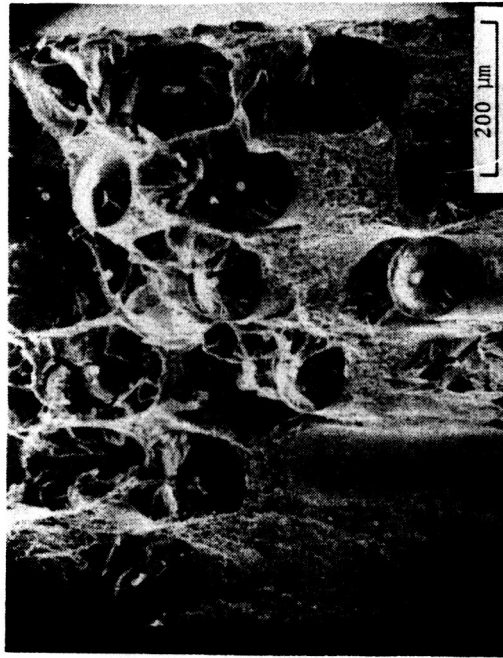
Figure 23.- Fracture surfaces of B/Al cyclically exposed between 293 K and 728 K.

Typical fracture profiles of B/Al and Bsc/Al specimens are shown in figures 21 and 22, and SEM fractographs of these specimens are shown in figures 23 and 24. The fracture profiles and surface morphology of these specimens show that the fracture mode changes with cyclic thermal exposure. The unexposed B/Al specimen (fig. 23(a)) failed in the noncumulative mode seen in the continuous thermal exposure specimens. The thermally cycled B/Al specimens (figs. 23(b), (c), and (d)), however, failed in a mixed fracture mode as transition from the noncumulative mode to a cumulative mode occurred. The cumulative mode (ref. 9) is characterized by axial shear-step failures in the matrix, nonfragmenting fracture of the fibers, and fiber pullout from the matrix. This type of fracture mode is indicative of poorly bonded materials and weak interfacial strength. The Bsc/Al specimens (fig. 24) had the same shift in fracture mode, but to a lesser extent.
